# Manhole Inspection Summary

Manhole # S41UU\_017MH

Insp Date: **2/23/07 9:03 AM**

**Location** Address: **2654 KIRK AVE**

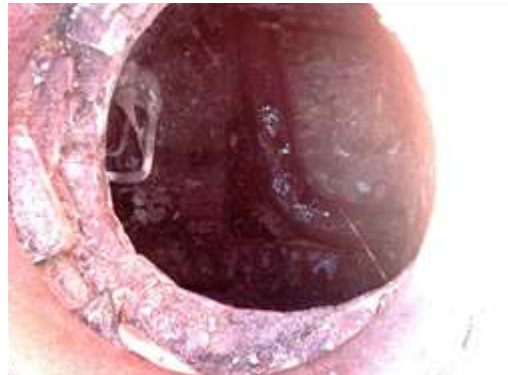
Top View

☐ Parged ☒ **Debris** (not Condition related)

**Surcharge** ☒ **Evidence Of Surcharge** Depth: **3** (ft.) ☐ Active Surcharge Present

Evidence of surcharge - Bench debris.

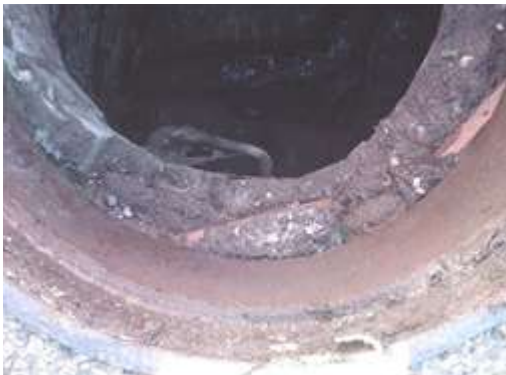
Defect

☒ **Leaks**

Condition: ☐ Sound ☐ Cracked ☐ Root Intrusion ☒ **Loose Brick** ☒ **Deteriorated**

Infiltration: ☐ None ☒ **Joint** ☐ Cracks ☐ Mortar ☐ Roots ☒ **Wall**

Frame leaks. Frame offset. Adjustment deterioration, loose brick and infiltration.

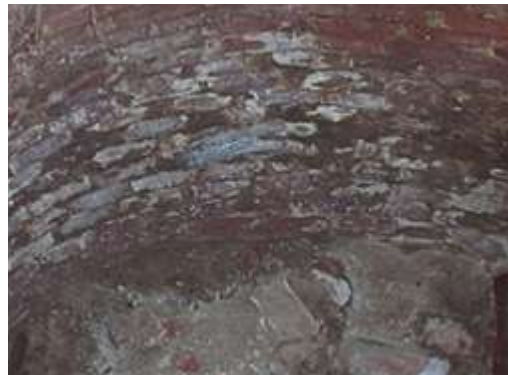
Defect

Infiltration: ☐ None ☐ Joint ☐ Cracks ☒ **Mortar** ☐ Roots ☒ **Wall**

Barrel infiltration.

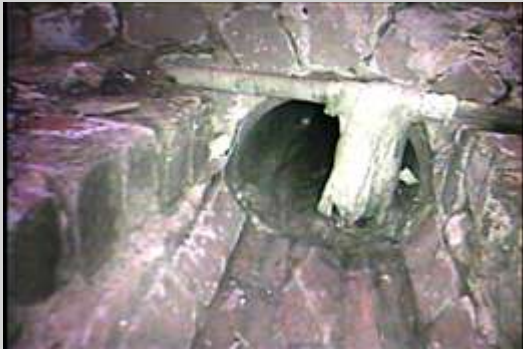
### 8 in. Circular Gravity Sewer Pipe Out @ 12 O'Clock

Condition: ☐ Sound ☐ Cracked ☐ Root Intrusion ☒ **Deteriorated** ☐ Leaks ☐ Debris

Channel deterioration.
